# WRONG

# ROOFS

date 06.05.2013 - rev 001 - ref WrongRoofsVetro--001

**Vetroasfalto SpA**

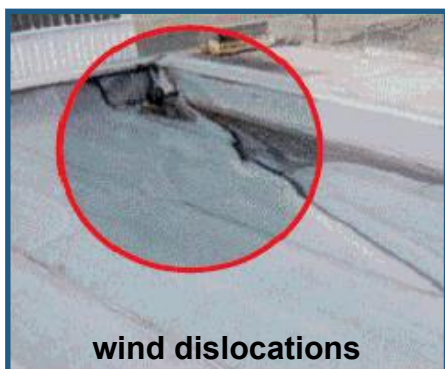
wind dislocations

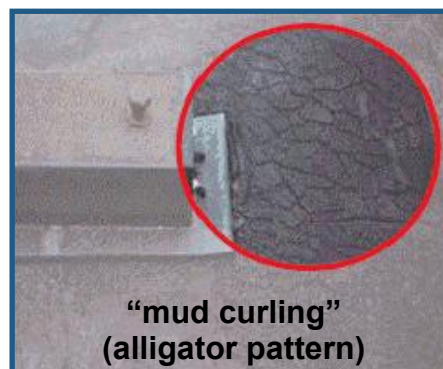
"mud curling"  
(alligator pattern)

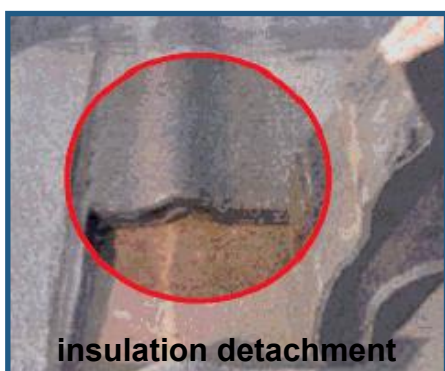
insulation detachment

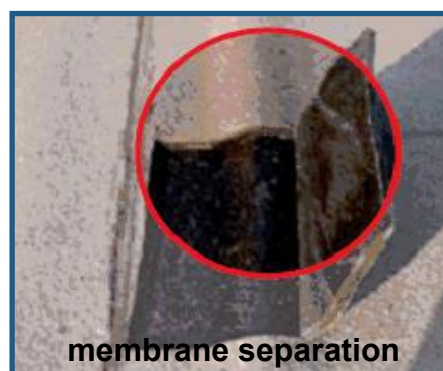
membrane separation

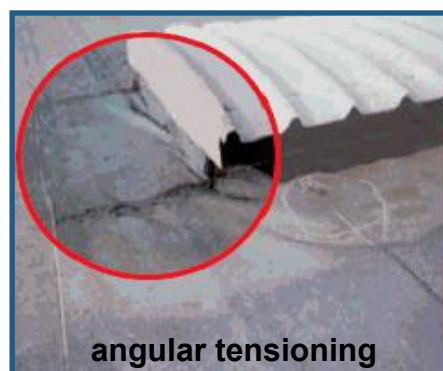
angular tensioning
